BULGARIAN FIGHTER COLOURS 1919–1948

Vol. 1

Rainbow No 9136

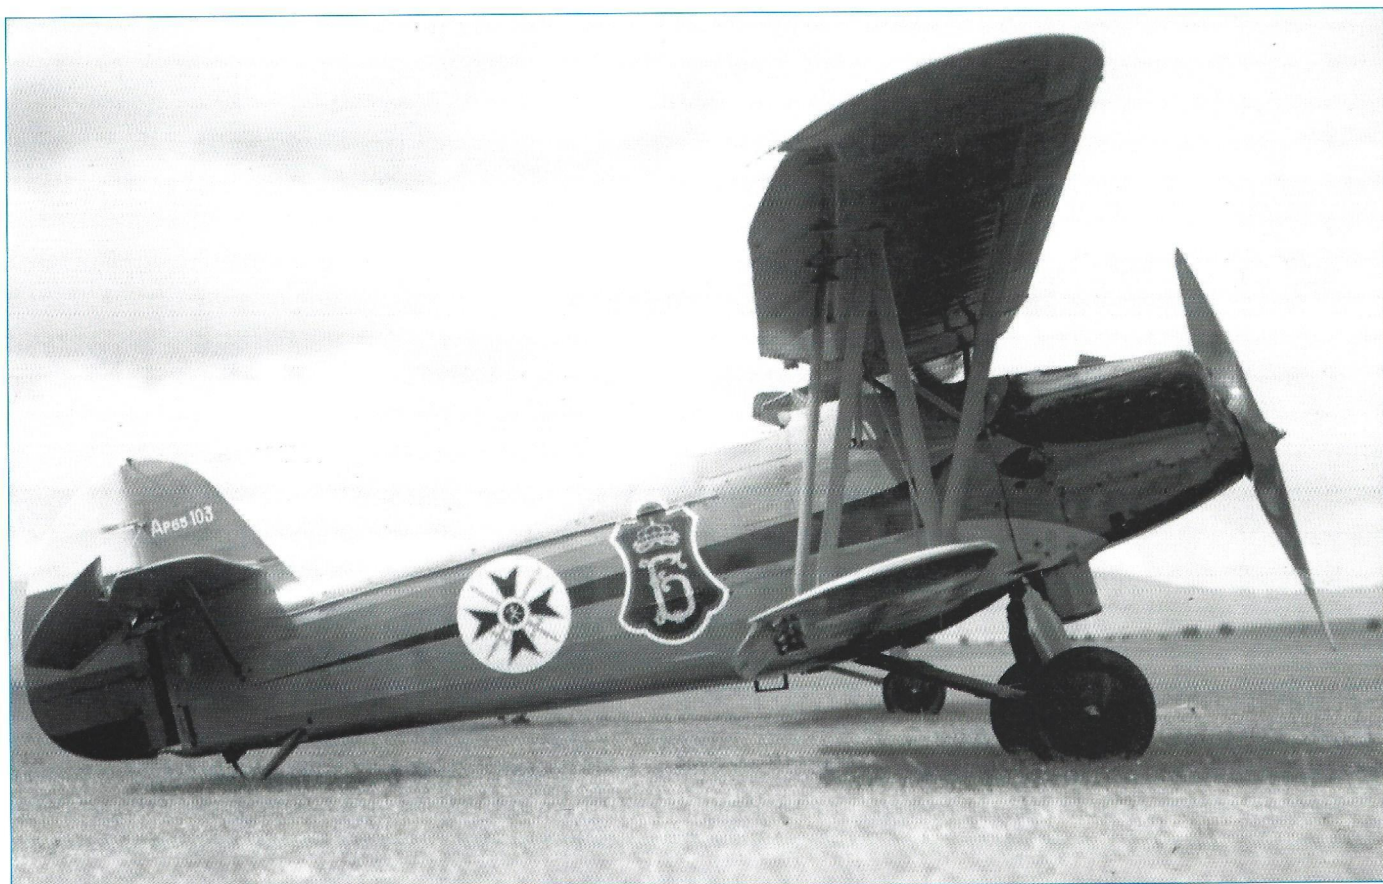
1. This beautiful silhouette study of an Arado Ar 65F fighter, taken in 1938, is a fine example of a German aircraft delivered to Bulgaria in an overall Light Grey livery. Additional ornaments were Red wraparound engine cowling and rearward tapering flash, tricolour rudder, as well as the typical colourful Bulgarian markings.

The first fighter aircraft types impressed in the Bulgarian Air Force (VNVV) in 1937 were German and Polish ones (Heinkel He 51C and Arado Ar 65F, as well as the PZL P.24B). [Photo 1] The Focke-Wulf Fw 56A fighter trainer also came from Germany, in 1937. Obviously, these aircraft arrived finished with paints and lacquers available in their countries, but considering their export status, which will be detailed later on.

Based on available photographs, the first imported fighter and fighter trainer aircraft types may have arrived in Bulgaria in two distinctive paint schemes: one consisted of Dark Green upper surfaces over Light Blue, or Silver [Photo 2]; while the other one, less common, of overall Light Grey [Photo 1]. The first instinct of the Author, before finding the aforementioned German invoices in the Bulgarian archives, was to select the matching aircraft paints available at that time to *Luftwaffe* aircraft, namely RLM 62 *grün* for Green (the often quoted RLM 71 *dunkelgrün* is out of the question, as it appeared only later on) and RLM 65 *hellblau* for Light Blue. As for the Light Grey, the obvious choice would be RLM 63 *hellgrau*, or RLM 02 *RLM-Grau*. However, based on the research done on the painting standards of

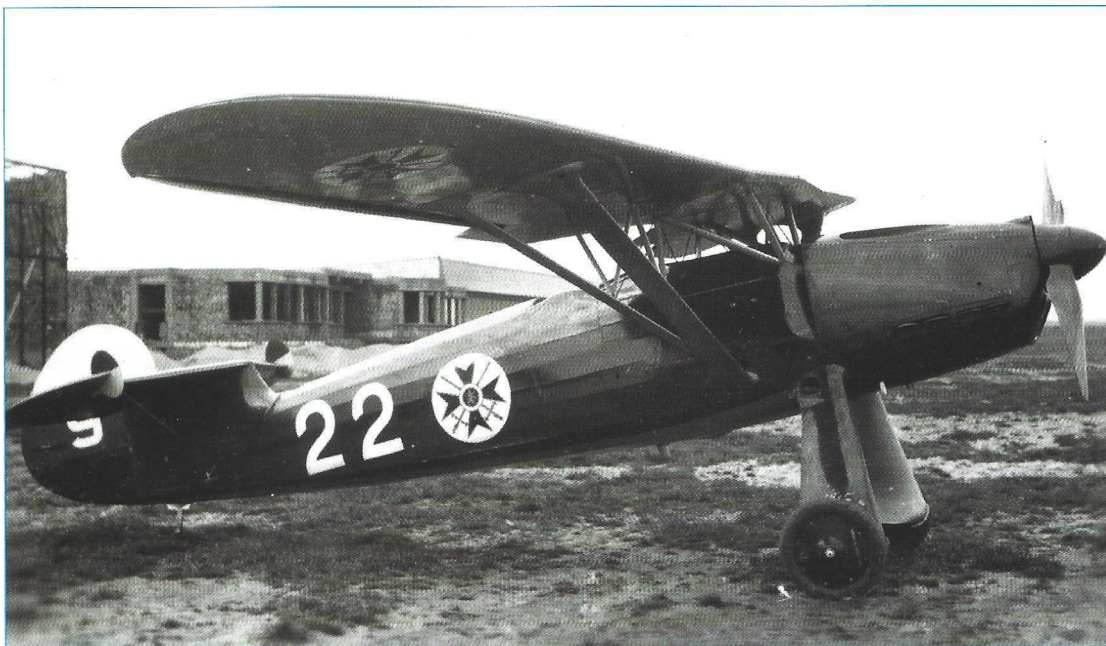
2. This photo of a Focke-Wulf Fw 56A fighter trainer, taken in 1937, is an example of the alternative paint scheme of German aircraft delivered to Bulgaria, consisting of Dark Green upper surfaces over Light Blue. The typical Bulgarian ornaments and markings are present here as well.

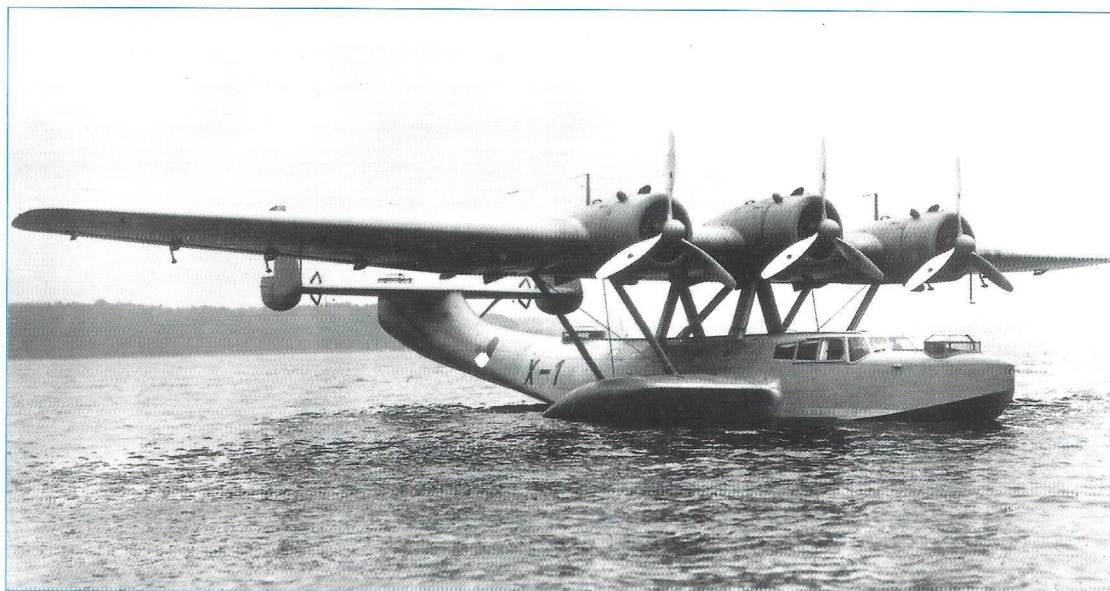
3. Case study of the airframe finish of German aircraft exported abroad in the 1930s [in this case, the first Dornier Do 24K flying boat – actually the Do 24V3 prototype, registered X-1 – delivered to the Netherlands, in July 1937]. See main text for details of the specific aviation paints used on the airframe.

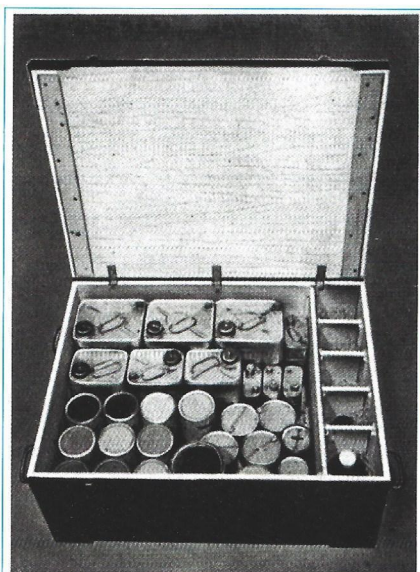
Abb. 60 Kiste Farben, Öle, Fette

7. Typical repair paint and oil toolbox, supplied with every German aircraft. This particular box contains the following paints (as per the original manual's description): F: Flieglack Fl 7122.02, Fl 7122.76, Fl 7122.075, Fl 7122.74, Fl 7160.22, Fl 7160.21, Fl 7130, Fl 7135.02 (each sample stored in 2 kg tins). Along with paints, diluents (thinners) were also supplied, as follows: Verdünnung Fl 7200.00 and Fl 7230.00, the former in 5 kg, the latter in 1 kg amounts. It is not known which aircraft type this toolkit was supplied with; however, judging by the camouflage colours Farbtöne (colour shades) 74/75/76, most probably it was a day fighter aircraft.

The offer by Messerschmitt AG to the Royal Bulgarian Ministry of War of spare parts and other matériel for Bf 108 and Bf 109, dated 29 January 1941, includes aircraft lacquers and paints as well. The offer lists *Flieglacke* (aviation lacquers, i.e., paints) L 40/62, L 40/65 and L 40/70 (without giving the colour shades), as well as a small dose of Black marker paint (no code is given), along with the matching diluent (thinner), manufactured by DKH. The text clearly refers to “the 10 *Jagdeinsitzer* [single-seat fighter aircraft] Me 109E delivered by us in 1940.” This is the single direct link between a particular aircraft type and the camouflage paints used, mentioned previously. [Photo 7]

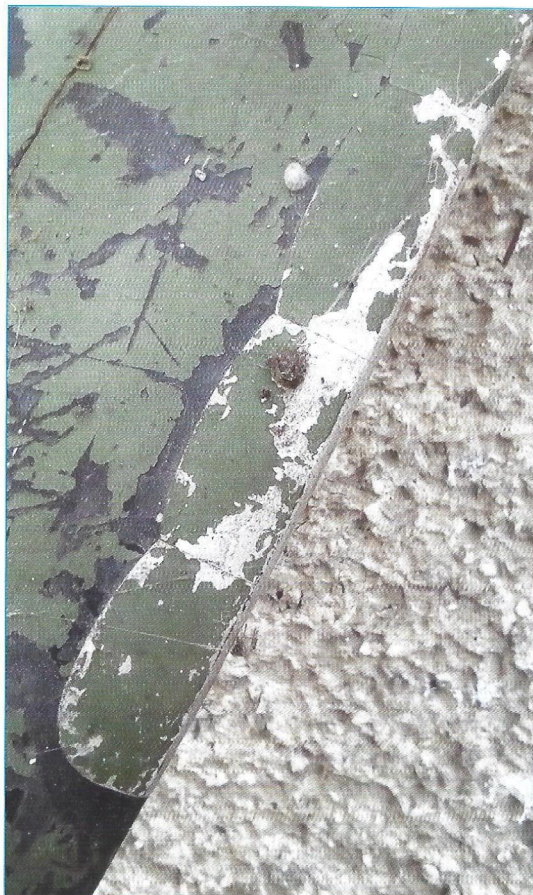
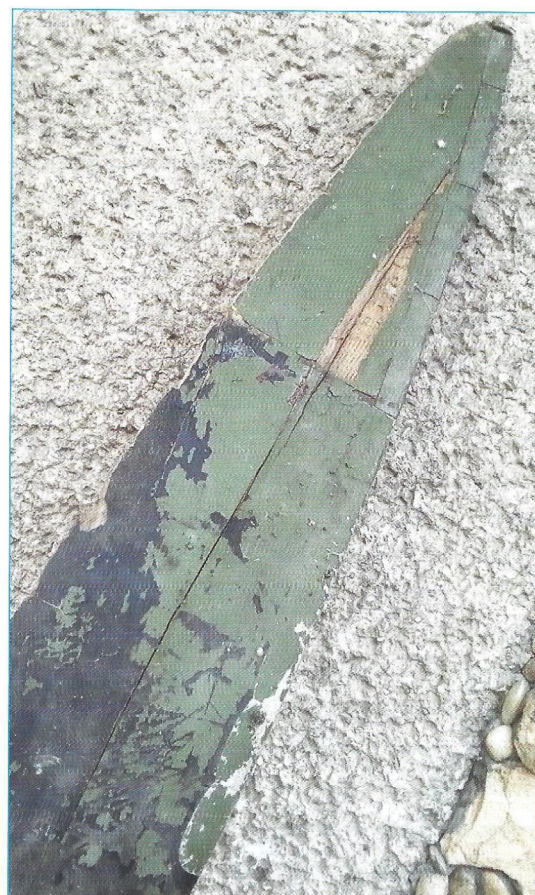
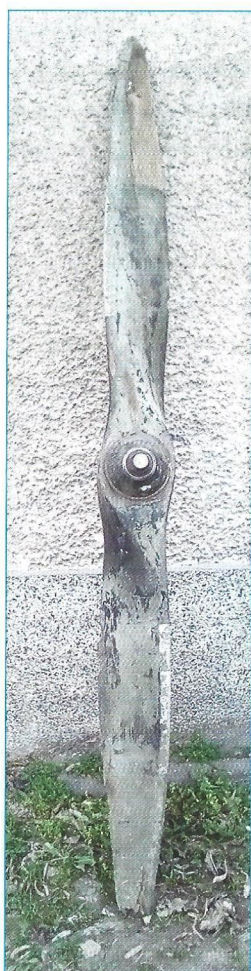
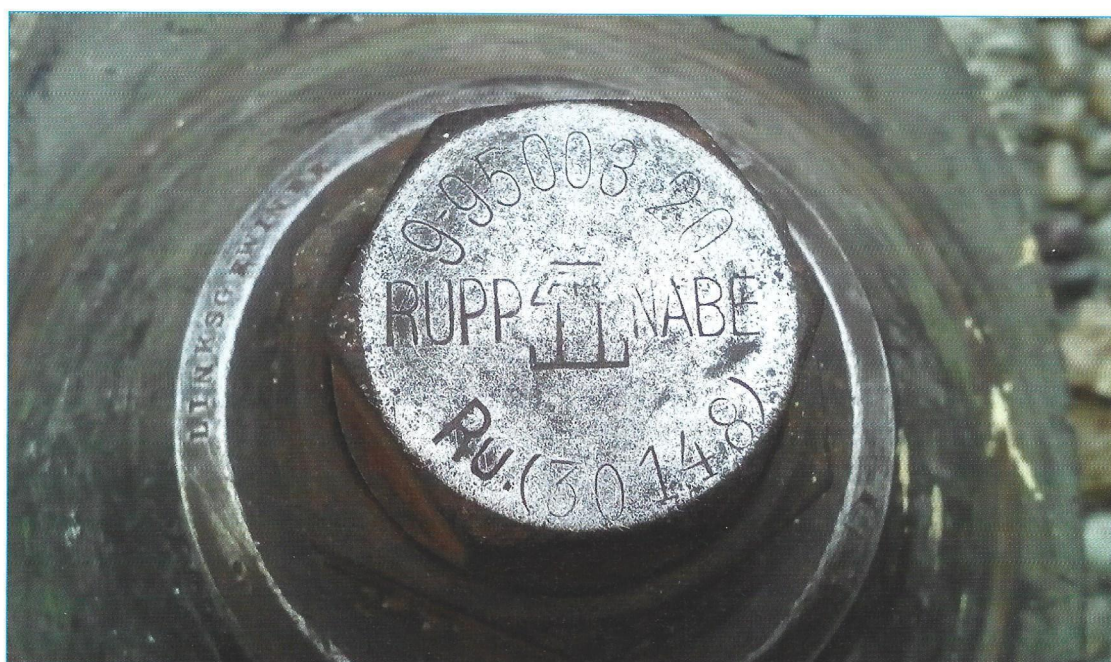
These photos of a surviving wartime propeller were sent from Razgrad, in the 11th hour (just days before the manuscript was closed). Reportedly, the German-made propeller was removed from an early DAR-3 Garvan I trainer aircraft, although several other aircraft types would fit as well. Of utmost interest is the mid-Green colour that survived on parts of the propeller. This is an ultra-rare occasion to see a genuine camouflage colour shade used during the war, even if it was faded by the sun. (Photos G. Dimitrov)

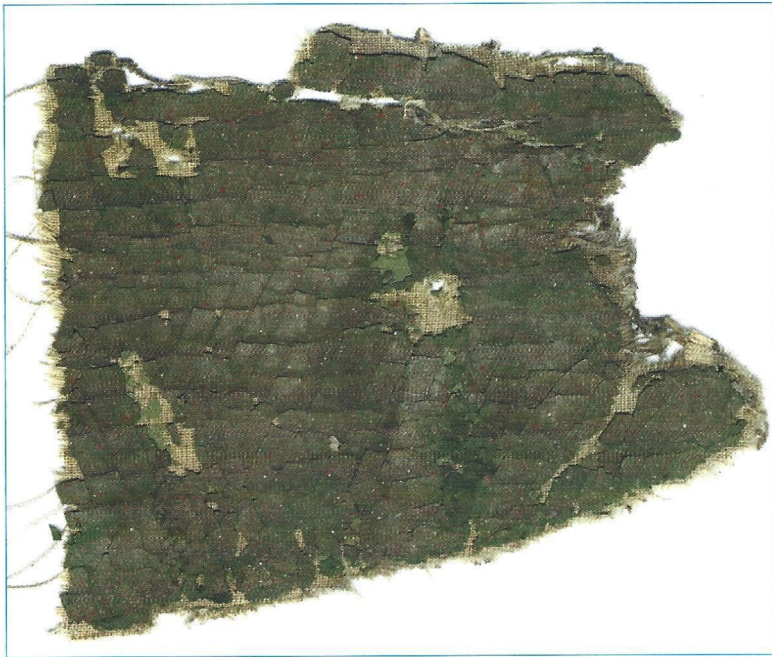
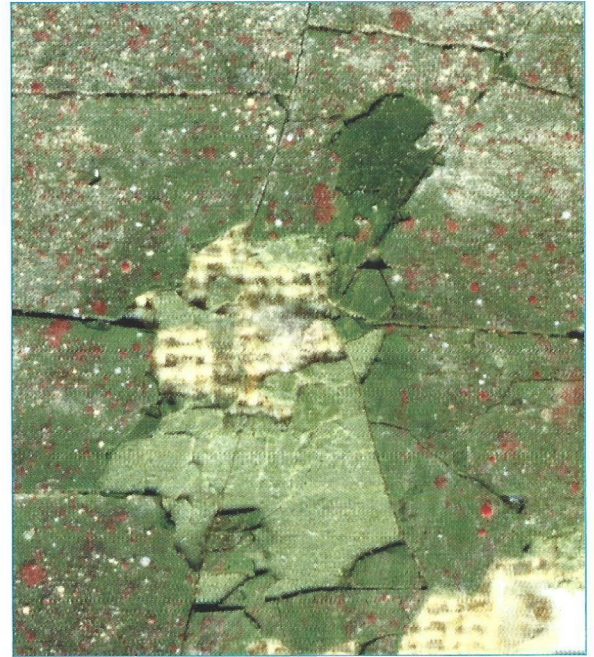
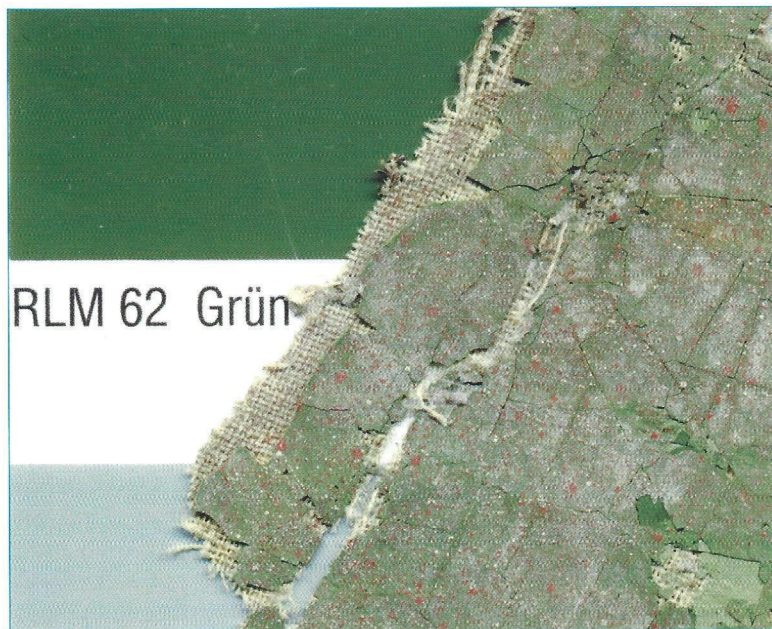
This small piece of fabric originates from an unidentified Bulgarian aircraft, which reportedly flew during wartime. It is the only such genuine piece the Author has come across and owns. Unfortunately, 99% of the original dark green paint chipped away, only a tiny dot remained. The Author placed the fabric onto an RLM 62 Green paint chip attached to the book 'Luftwaffe Colours, 1935–1945', by Michael Ullmann (Hikoki, 2002). Obviously, no exact match can be ascertained of this small sample (see lower right area); however, the similarity of the colour shades is apparent. RLM 71 Dark Green and RLM 70 Black Green were all visibly darker than the mid-green dot on the fabric. If anyone has genuine parts, or wrecks of Bulgarian aircraft used during the war, with even small amount of camouflage paint preserved on them, the Author would be delighted if he was contacted through the e-mail address given on bottom of page 6. The information could be used in future books related to Bulgarian aviation.

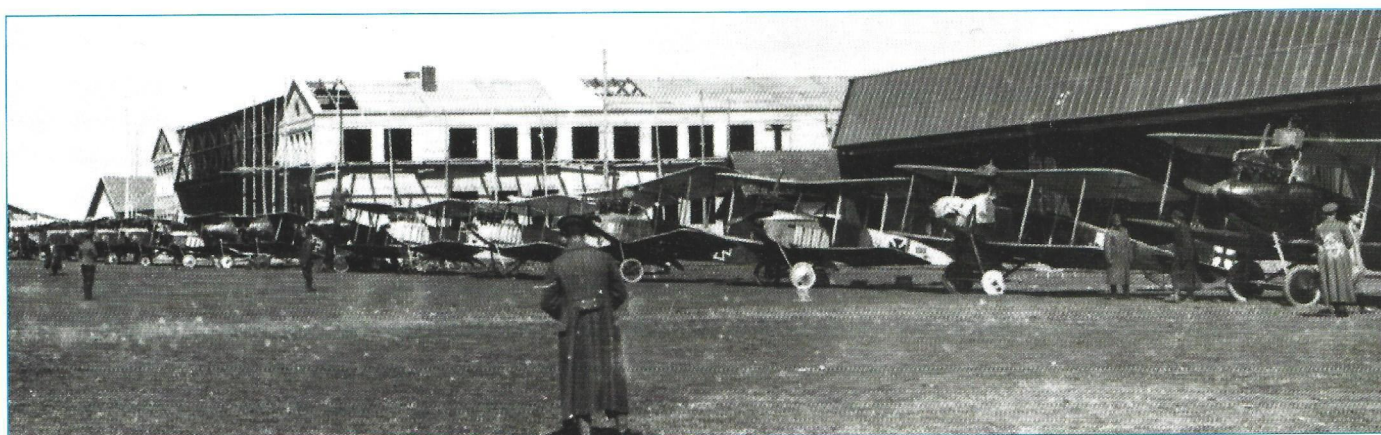
2A. Right after the war's end, some of the surviving Bulgarian warplanes displayed a newly introduced, albeit unofficial, Allied-inspired cockade, which consisted of Bulgaria's national colour of white (outside ring), green and red (inside dot). Depicted is an Albatros Flugzeugwerke-built Fokker D.VII fighter, No. 5322/18, with the aforementioned cockade partly visible in the right bottom corner.

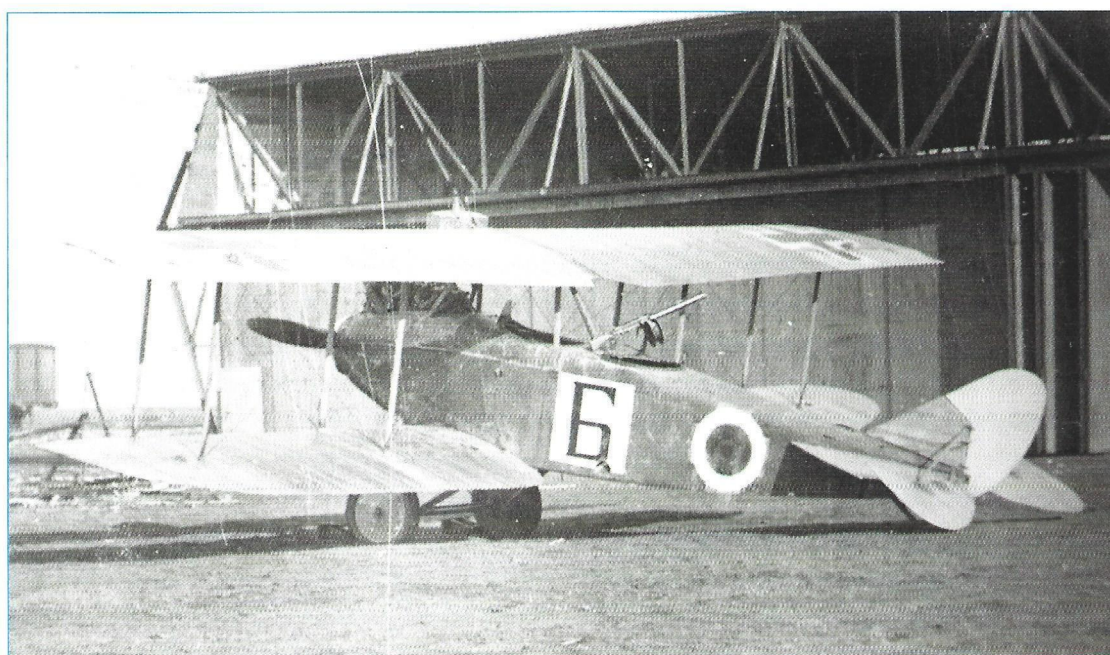
3. This photo of a rubber tyre-less Albatros C.III general purpose biplane was taken from the final report compiled by RAF Captain F. Wells. Notice the previous Central Powers marking on the fuselage and tail had been overpainted in white.

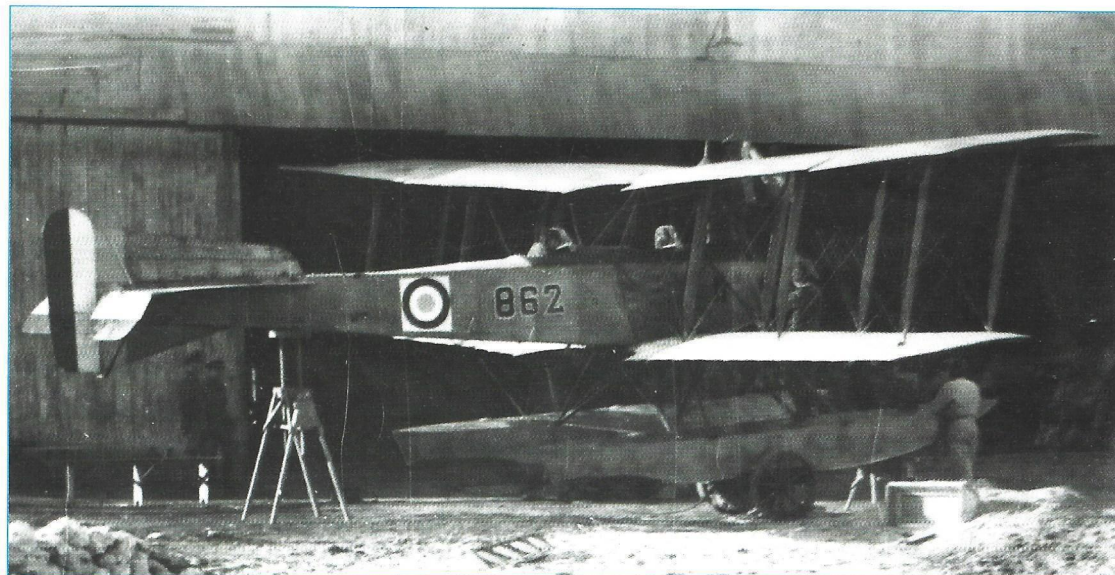
5A. A Bulgarian manned Friedrichshafen FF.33E (1916, Naval No. 862) type seaplane photographed at Varna seaport by RAF Captain F. Wells in early 1919. The aircraft displays French cockades on fuselage and wing surfaces, applied right over the obsolete Central Powers marking (covered with white squares), as well as vertical red-white-blue tricolour bands on the rudder.

As noted, these markings were observed on land-based aircraft collected at Bozhurishte airfield during the winter of 1918/1919. The seaplanes assembled at the main seaport of Varna, on the shores of the Black Sea, around the same time, also wore makeshift roundel type marking. This was applied over the obsolete cross-type marking. However, this time, the colours and their arrangements were identical to those of the French marking, namely blue dot in the centre, surrounded by two rings, the middle one being white, the outer one red. The tricolour roundel was applied on the mid-fuselage (over a white square), while the rudder was divided vertically in three equal areas, the inner one being painted blue, the centre one white, and the outer one red, consistent with the French national colours. [photo 5A and 5B]

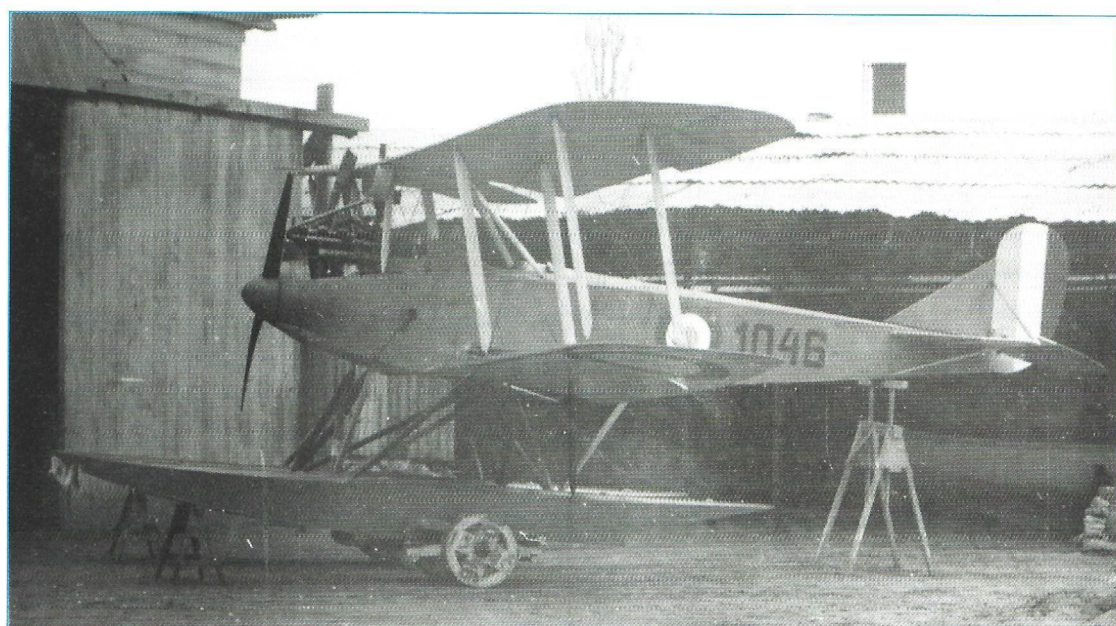
5B. Rumpler 1916 seaplane (No. 1046), also photographed at Varna seaport in early 1919. This one also displays French cockades on fuselage and wing surfaces, and blue-white-red tricolour stripes on rudder.

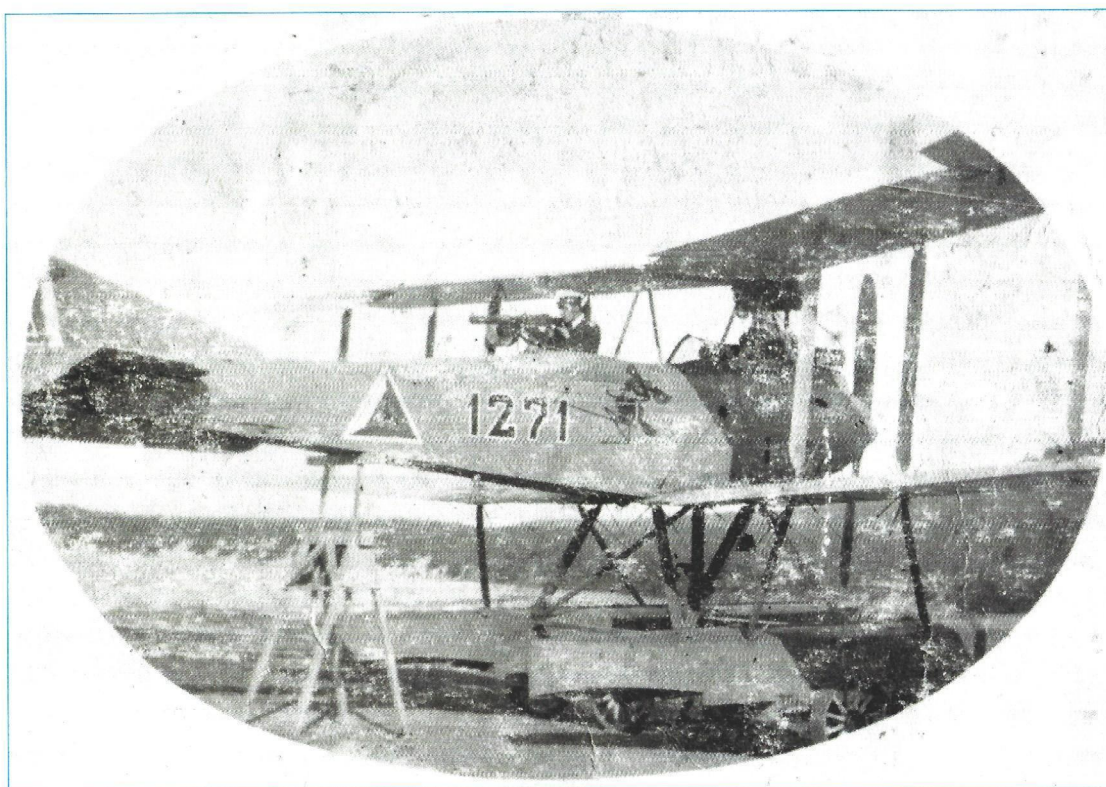
6B. Original photo of the aforementioned seaplane, No. 1271. This marking was used only briefly, probably between 1918-1920.

There was a notably different type of marking, observed on a Friedrichshafen FF.33L type seaplane (No. 1271) by the same Capt. Wells. The marking consisted of a multi-coloured triangle, with white, green and red borders, each 2' (609.6 mm) long, with a yellow rampant lion in the centre, on a crimson background. This marking was applied on both fuselage sides, on the rudder, as well as on the upper surface of the upper wing and the lower surface of the lower wing, in a larger version, with the sides of the equilateral triangle being 5' (1524 mm) long each. [photos 6A and 6B]

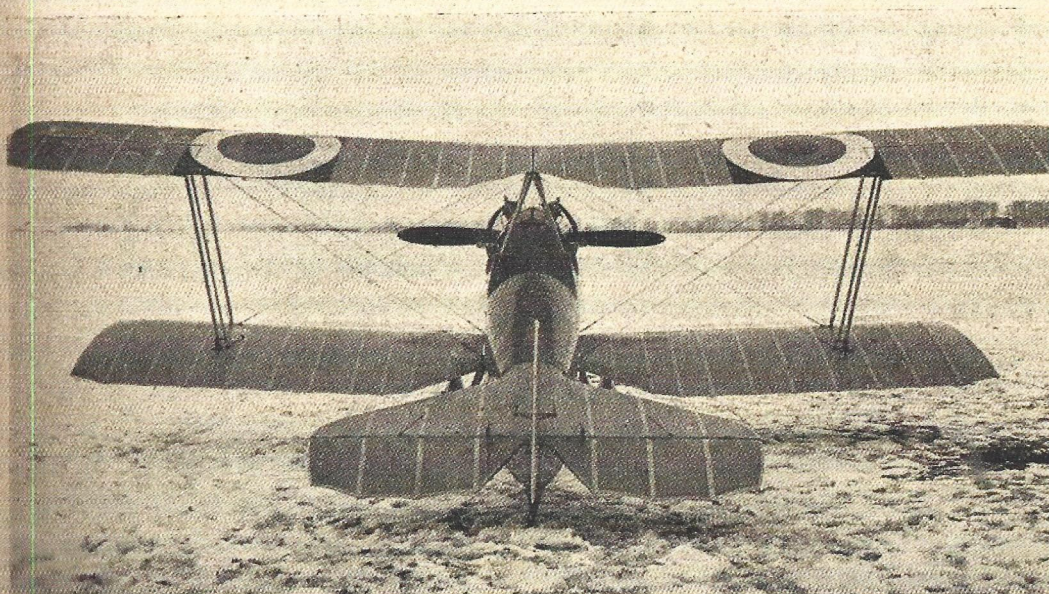
Разпереностъ	8 м.
дължина	5.70 „
височина	2.50 „
носяща площъ	20.20 кв. м.
тегло празенъ	250 клг.
полезенъ товаръ	230 кгр.
общо тегло	480 кгр.
натоварване на кв. м.	24 кгр.
„ „ „ К. С.	8 кгр.
скоростъ при земята	142 клм.
скоростъ при кацане	40 клм.
максимална височина	4000 м.
изкачва 2000 м. за 11 м.

10. The same aviation magazine *Letets* published a photo as illustration to the technical characteristics of the Potez VIII where the military marking applied to the wing upper surface is clearly seen. The cockade type insignia, applied over a black square, consisted of a red dot in centre, surrounded by two circles, green in the middle and white outside – identical to the roundels worn briefly in 1919/1920.

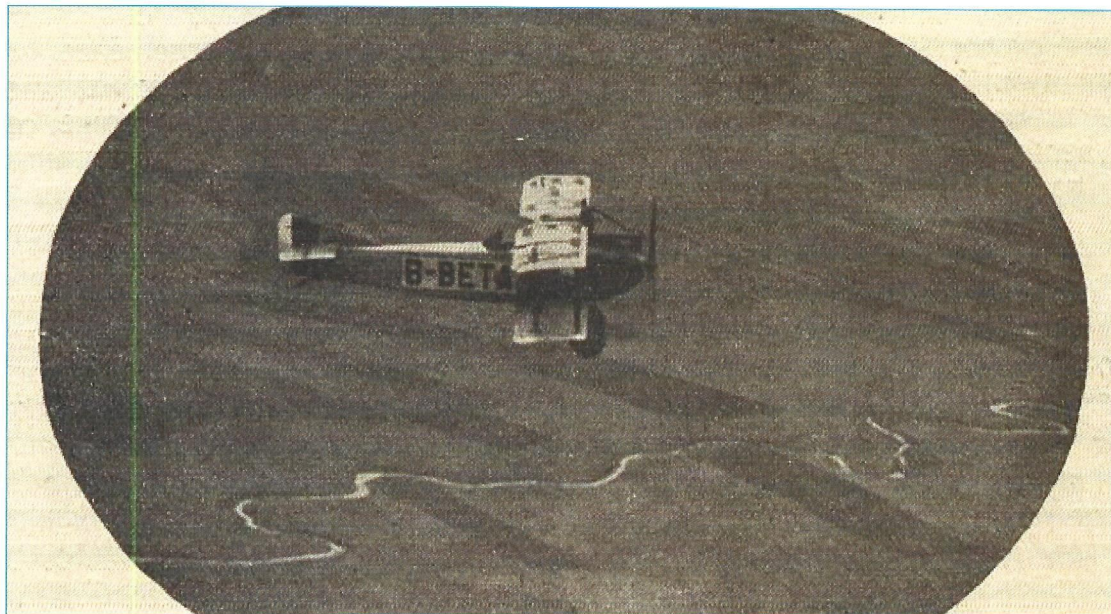
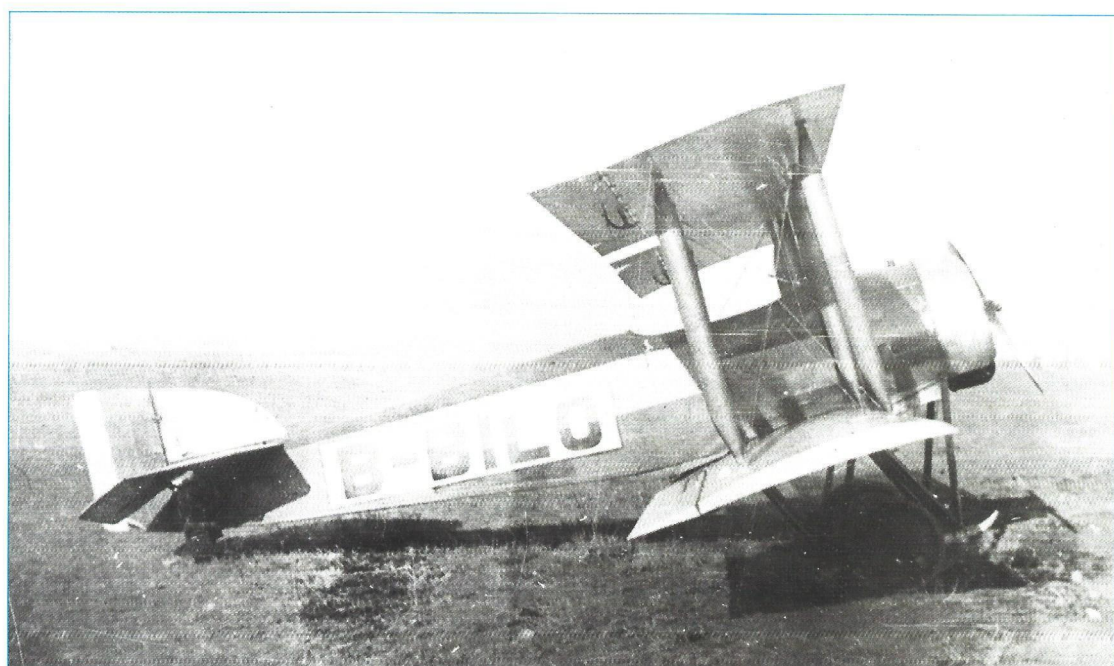
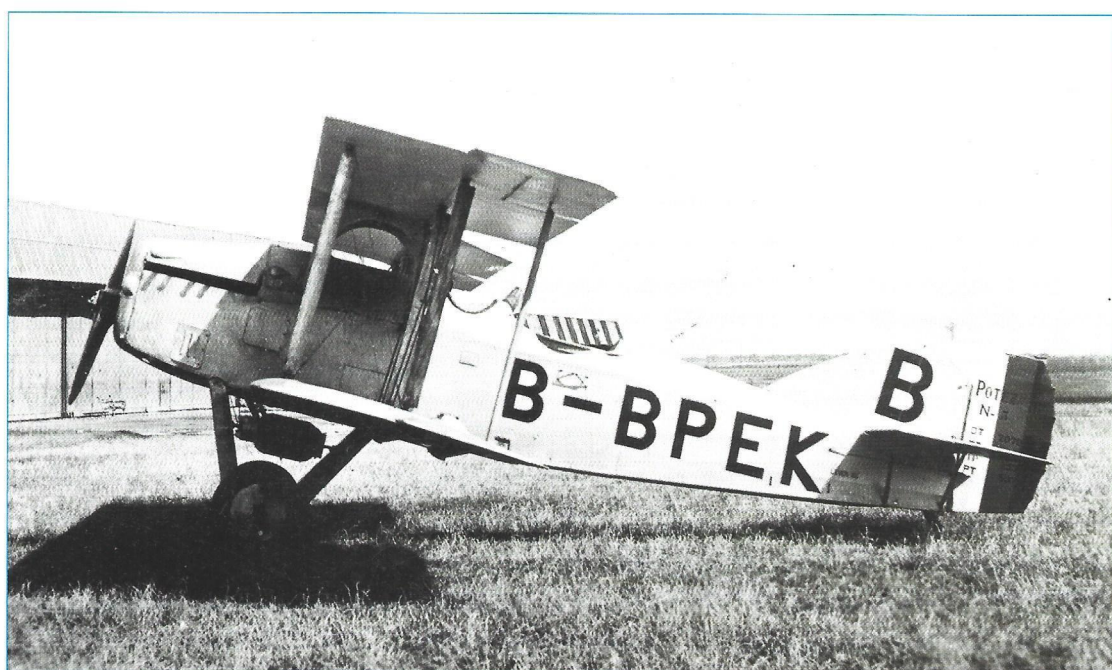
11, 12, 13. As noted earlier, the order the Bulgarian national colours were applied on the rudder varied. E.g., on the depicted Potez VII (B-BILO) and Caudron C.59 (B-BETA) it was the red stripe that was inside, close to the fin, while on all Potez XVIIs (B-BPEK) it was exactly the opposite, the white stripe was inside. Later on, apparently the latter version, with the white stripe inside, became standard.

the natural coloured skin (fabric or plywood). [photo 16] There were cases, however, when the registration was surrounded by a white or black rectangle. On other occasions, the black letters were applied over a white rectangle, bordered in black. [photo 11 and 12] Although in most situations the registration letters were plain black, in certain instances the black letters were outlined in white. In many cases the last four letters of the registration were underlined with a black horizontal line. [photo 17] This practice purportedly denoted private aircraft, although all Bulgarian air vehicles – with the exception of the two Junkers F13 transports, which belonged to the short-lived BUNAVAD domestic airline – were owned by the state. In other cases, the registration letters were not underlined. Curiously, even within the same aircraft type, both versions could be observed (for example, the Potez XVIIIs). The letter B, officially to be applied on the rudder, was either omitted (as the rudder was painted in Bulgarian colours), or applied on the fin instead. Also, the same letter B which was supposed to be applied on both sides of the horizontal stabilisers (tailplanes), was either present or not. In rare cases, the civilian registration was followed by a dot (as was the case with the Avro 552s). This great variation of civilian registration styles prompts the would-be modeller of inter-war Bulgarian aircraft to use solely period photographs in order to build his/her scale model as accurately as possible.

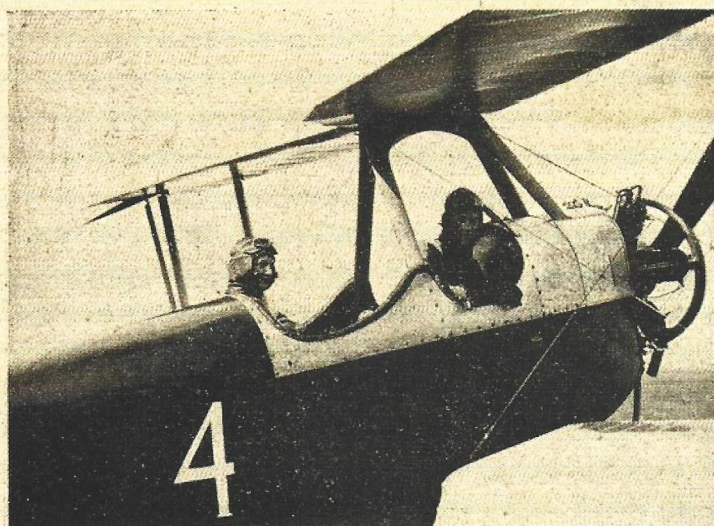
14. Instead of civilian registration letters, these early French aircraft were identified with Arabic numerals applied on the mid-fuselage, consistent to military style. Potez VIII, No. 4, is depicted on this photo taken from *Letets* magazine, issued in early 1924.

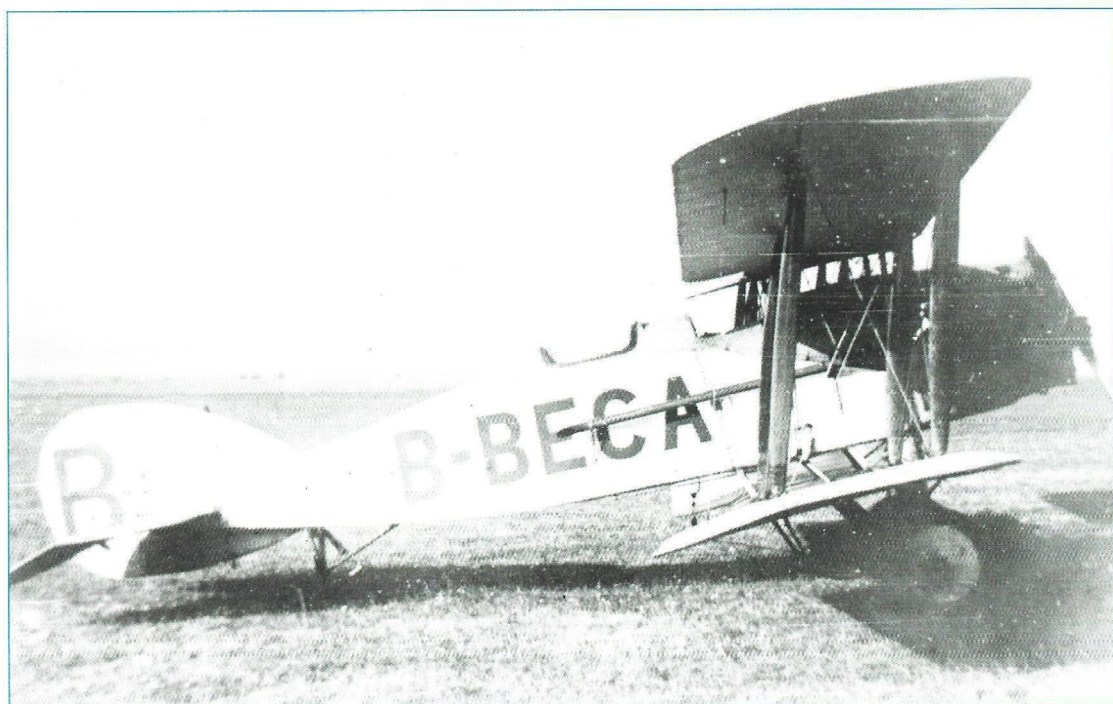
15. By contrast to the early French types, the aircraft imported from Great Britain arrived in full and properly applied civilian registrations. Depicted is B-BECA, a Bristol 88 'Bulgarian Tourer', which officially was the first civilian aircraft registered in Bulgaria, in April 1924. Notice the rudder devoid of the military-style Bulgarian national colours, instead a large letter B being applied on it (as well on the horizontal tailplanes), as per regulations.

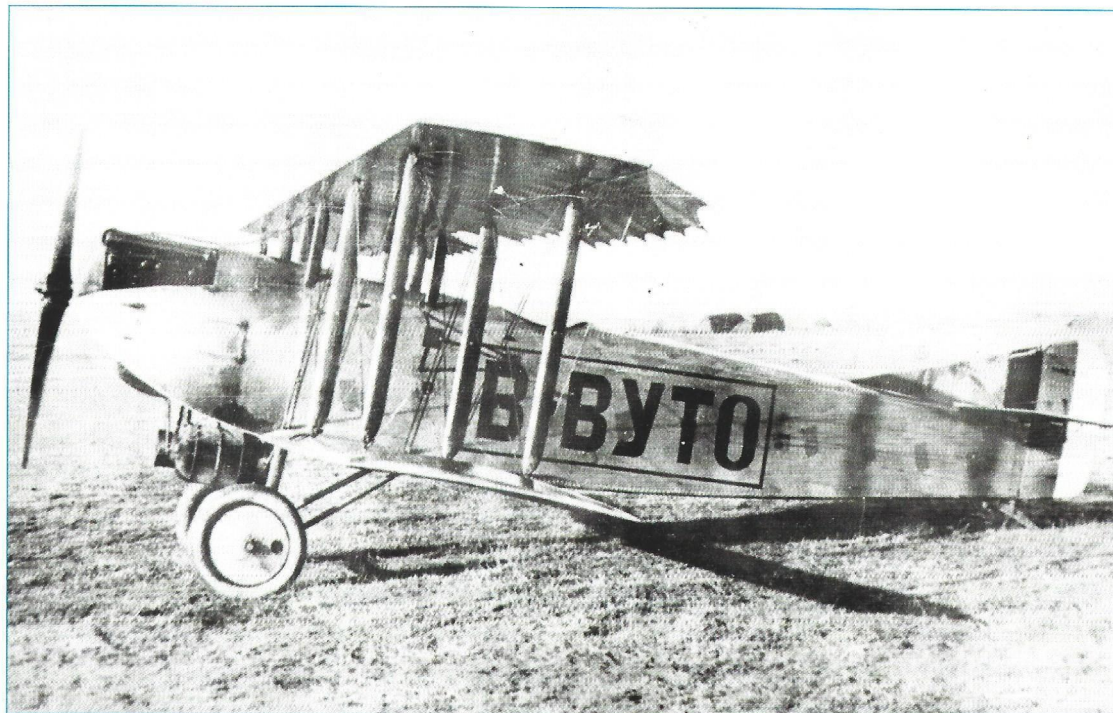
16. The style the civilian registration was applied on Bulgarian aircraft varied greatly. The simplest case was when the black registration letters were applied directly onto the fuselage sides and wings, right over the natural coloured skin (fabric or plywood). This was the case with the depicted Caudron C.59, B-BYTO, officially registered in May 1924.

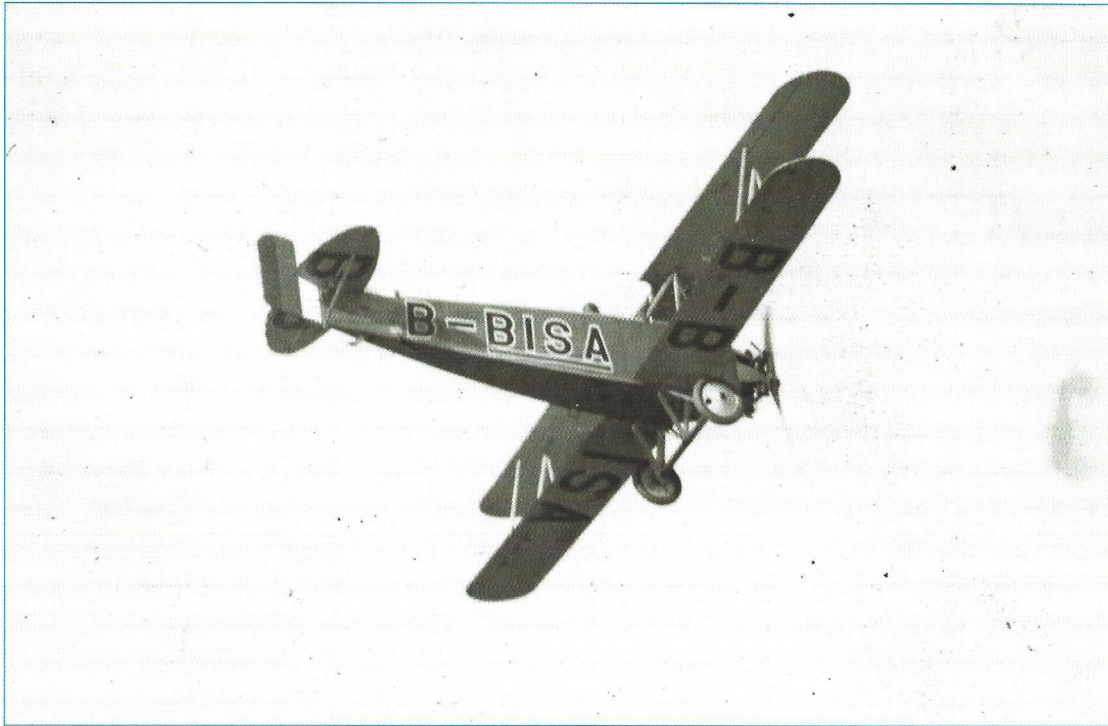
17. Although in most situations the registration letters were plain black, in certain instances the black letters were outlined in white, as was the case of B-BISA, a Letov Š-18 (Šmolík), registered in 1926. In many cases, including this particular one, the last four letters of the registration were underlined with a black horizontal line, which purportedly denoted private aircraft (although all aircraft were property of the Bulgarian State).

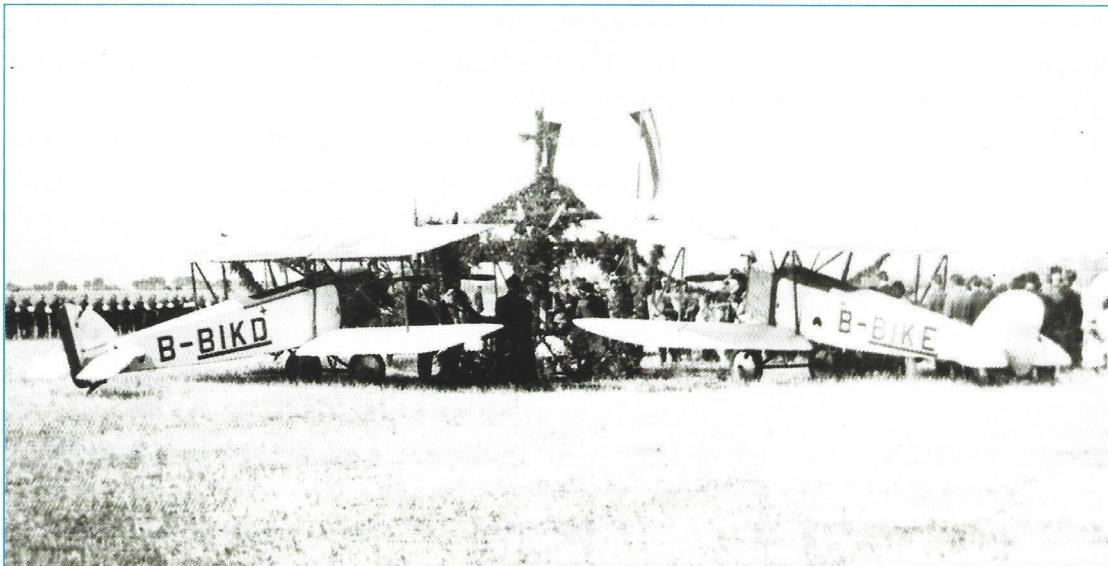
18. At one point, the direction the Bulgarian national colours were painted on the rudder changed from vertical to horizontal. This must have happened before 1932, as the depicted DAR-1 'Peperuda' (Butterfly) trainers still wear the B-B style register. Notice how B-BIKD, at left, has the colours aligned on the rudder vertically, while B-BIKE, at right, has the same colours applied horizontally. DAR-1 was the first truly indigenously designed airplane, by a team headed by German professor Dipl.-Eng. Hermann Winter.

At one point, most probably in 1930, the direction the Bulgarian national colours were painted on the rudder changed from vertical to horizontal. [photo 18 and 18A] Shortly after this, but independent-

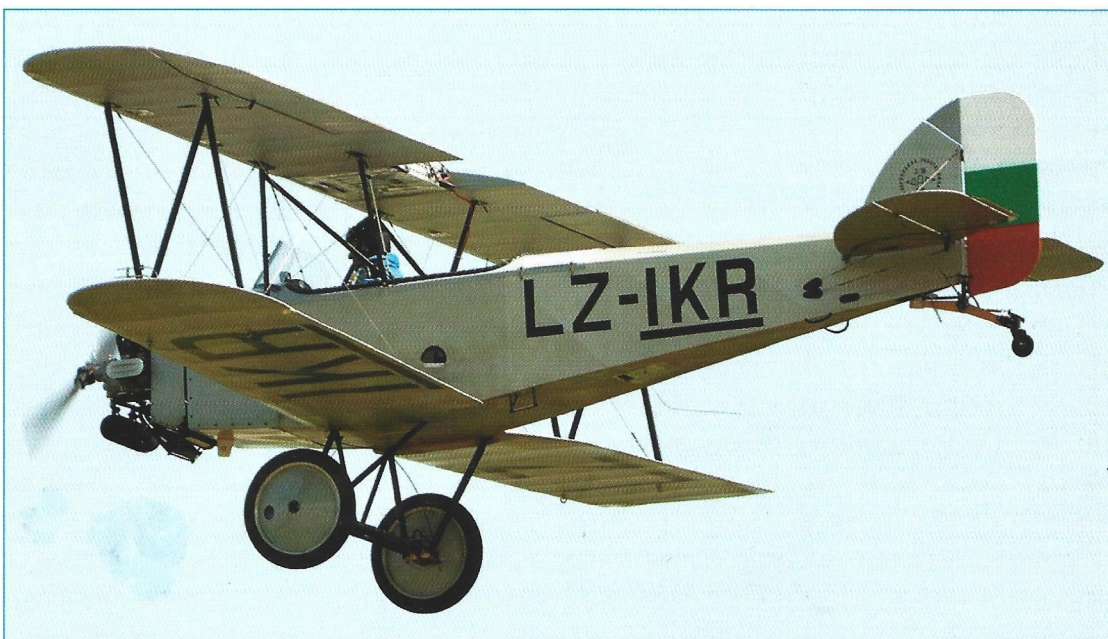
18A. Modern full-scale replica of the DAR-1, photographed in May 2009, showing all the markings and codes, as well as livery, Bulgarian civilian aircraft wore after the standards were regulated in 1931. (I. Donchev)

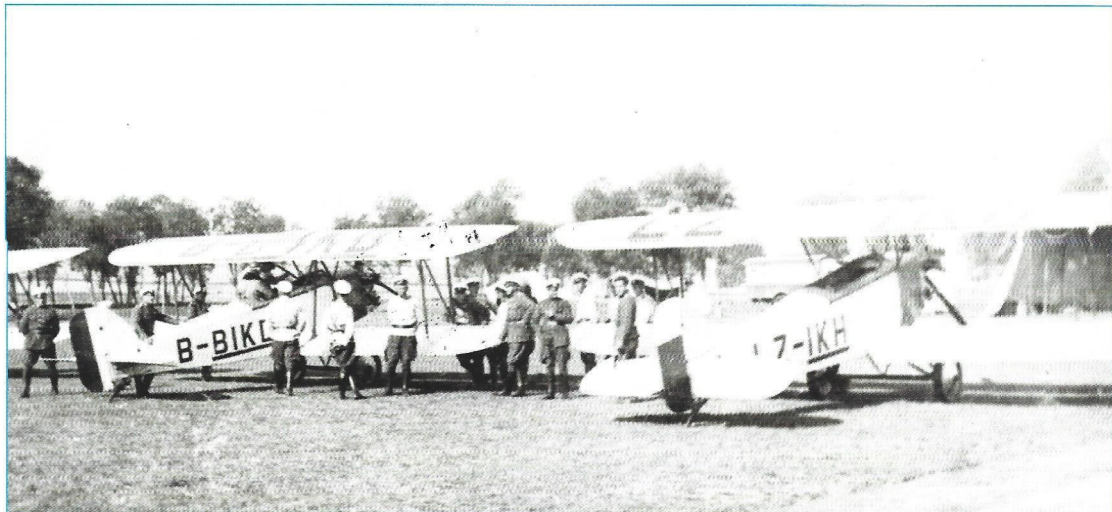
19. In accordance with the resolution of the International Radio Telegraph Conference held in Washington, D.C., on 25 November 1927, the civilian registration for Bulgarian aircraft changed from B-Bxxx to LZ-xxx. However, a couple of years had passed until all aircraft in Bulgaria actually changed their registration. This was officially due by the end of 1931; however, for a period after the deadline, both the old and new registration versions were visible on aircraft, until the B-B registration was finally phased out in 1932. This was the case with this pair of DAR-1s (B-BIKD, at left, and LZ-IKH, at right).

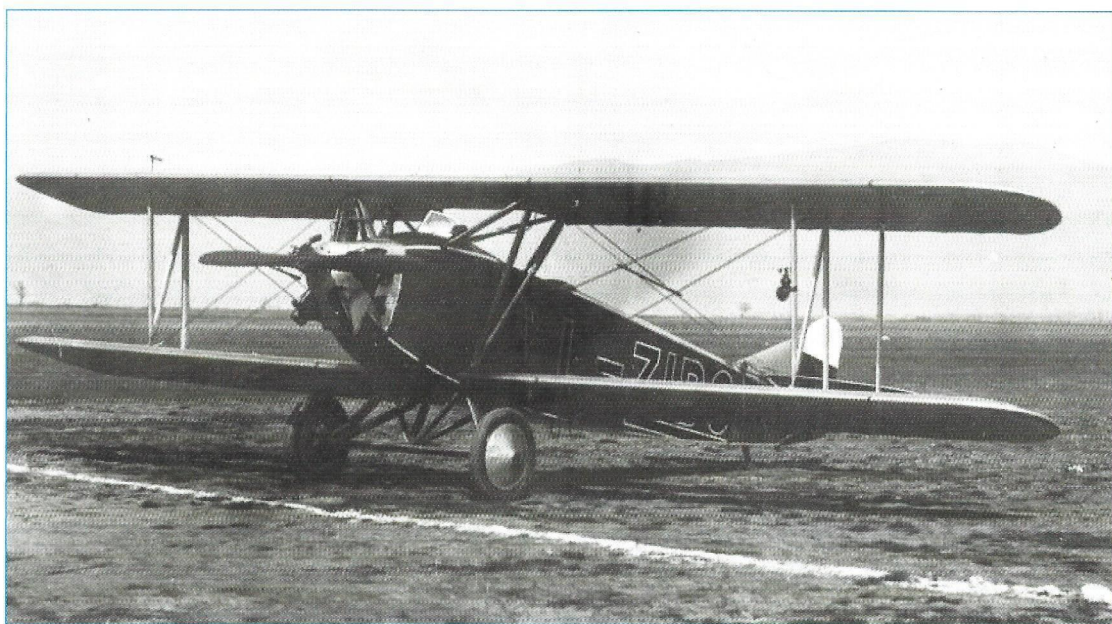
20. Theoretically, the old B-B country code gave way to the new LZ code, while the last three letters, identifying a particular aircraft, remained unchanged. However, there were odd situations, when the register was altered erroneously. This was the case of the depicted Letov Š-18, ex-B-BIBO, which became, for a short period in 1932, L-ZIBO, before switching to the regular LZ-IBO.

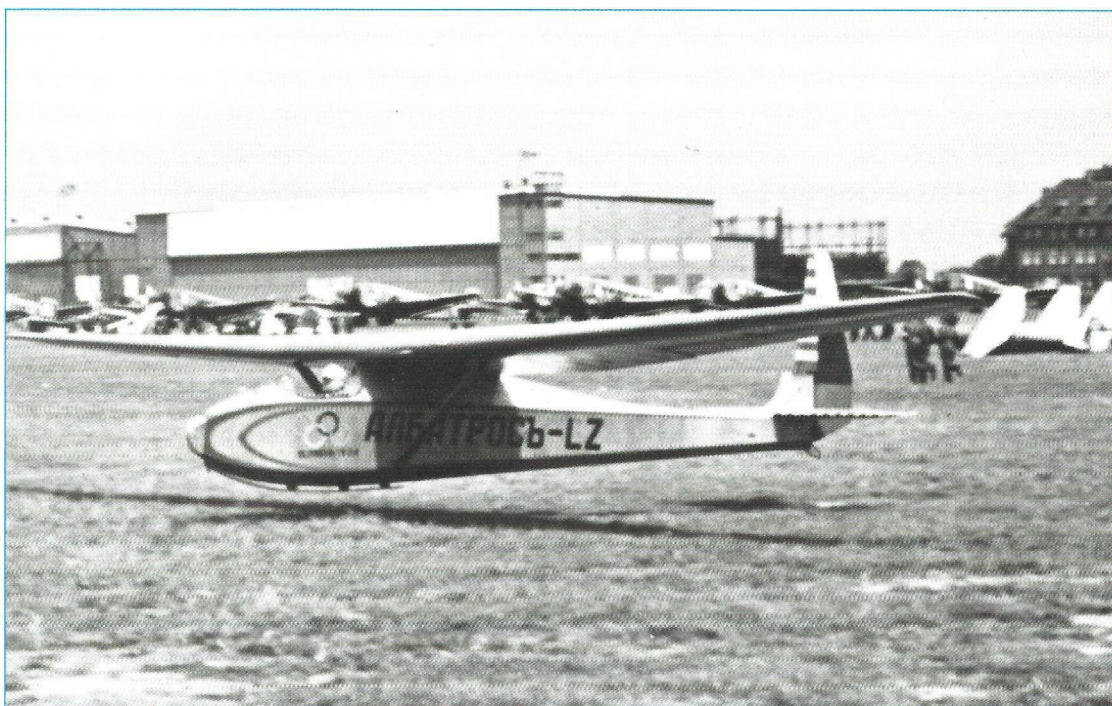
21. In 1935, DAR-Bozhur-ishte built three 'Komar' type gliders under Polish licence [called 'Albatros', 'Rilski Orel', or 'The Eagle of Rila (Mountain)', and 'Polska Chuchuliga', or 'Field Lark']. The first one participated at the Berlin Olympics in 1936, where reportedly it won a gold medal. 'Albatros' is depicted with the Olympic circles on its nose, followed by Bulgaria's civilian registration code LZ, in a form used by gliders when flying abroad.
